TEST REPORT

Test Report No: TR14-15

Test & Sample Details: Test on selected Nu-Wall horizontal and vertical Aluminium Cladding profiles in accordance with AS/NZS 4284: 2008 Testing of Building Façades.

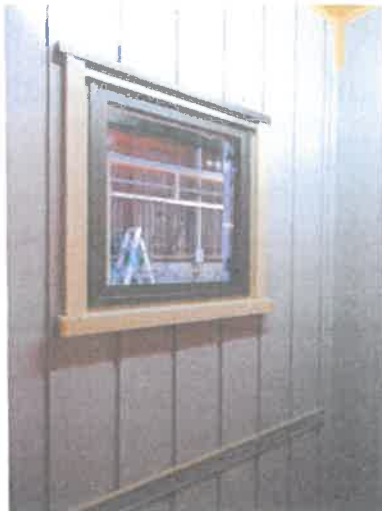
E200 vertical cladding

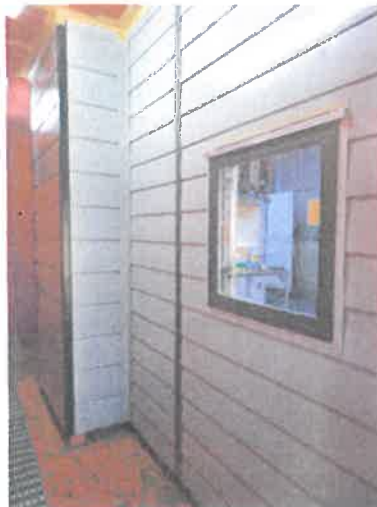
Louvre 150 horizontal cladding
Initial window

During the preliminary test the Nu-Wall aluminium cladding system demonstrated "no water penetration" at a test pressure of 455 Pa, but at a pressure of 750 Pa water penetration was observed from one end of the head flashing of the window installation in the horizontal cladding section. Testing was discontinued to allow the client to undertake redesign.

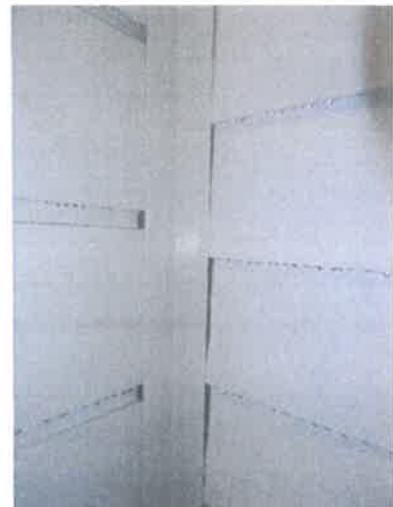
Internal corner horizontal
cladding
